Not Just Important — Critical

Watertightness is an essential trait of any onsite system tank. Here is a field-tested way to prevent leaks using a special clay called bentonite.

By Brian Rabe

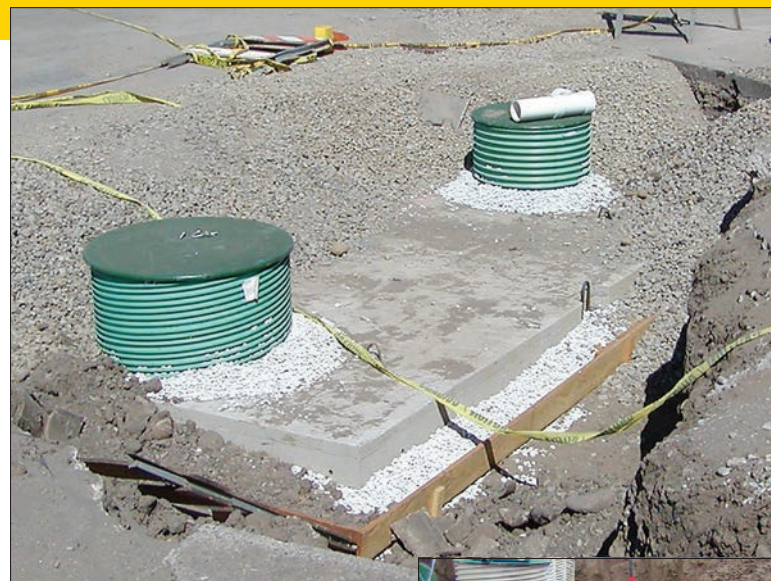
Bentonite in place around riser connections and the field seam before backfill.

Initially, I started specifying a band (about 6 inches wide by 6 inches tall) all the way around field seams on tanks. This works great as an insurance policy against infiltration. I now also include specifications for factory seams (cold joints) and would recommend using it around any patches of cracks, rock pockets or other imperfections.

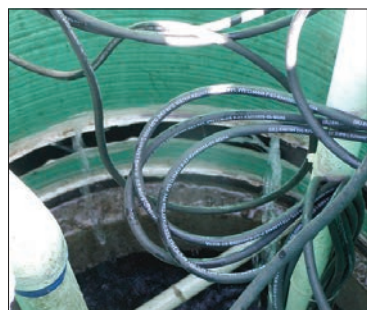
A couple of seemingly minor air pockets in the epoxy resulted in leaks (at least two steady streams can be seen in the picture). This amounted to thousands of gallons per day for a couple of weeks when the water table temporarily rose during a period of heavy rainfall.

Risers are another potential source of leaks. Even PVC riser material can have imperfections. I have seen ribbed risers (spiral type) weep at the factory seams, although I think that is rare. More often, I have seen leaks through the epoxy at connection points and splice joints. This is most often due to poor workmanship.

Close attention to detail is necessary to make sure that any air pockets in the epoxy are sought out and addressed. It is far easier to get it right during the initial installation than to have to dig it up, often in less than ideal conditions, to fix it.

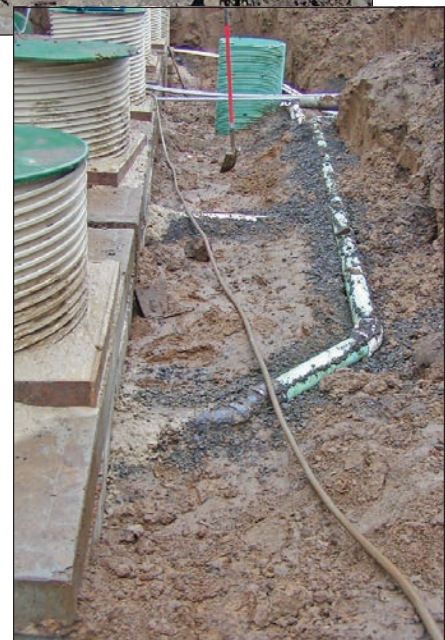
A good example of properly supported and bedded pipes with the risers and pipe penetrations reinforced with bentonite. Note that the field seam on the tanks has not yet had bentonite applied.

I began specifying the placement of bentonite around pipe penetrations a few years ago as insurance, but again, it is no substitute for proper workmanship.
